NACA TN 2920

INTERIM REPORT ON A FATIGUE INVESTIGATION OF A  
FULL-SCALE TRANSPORT AIRCRAFT WING STRUCTURE

By M. James McGuigan, Jr.

April 1953

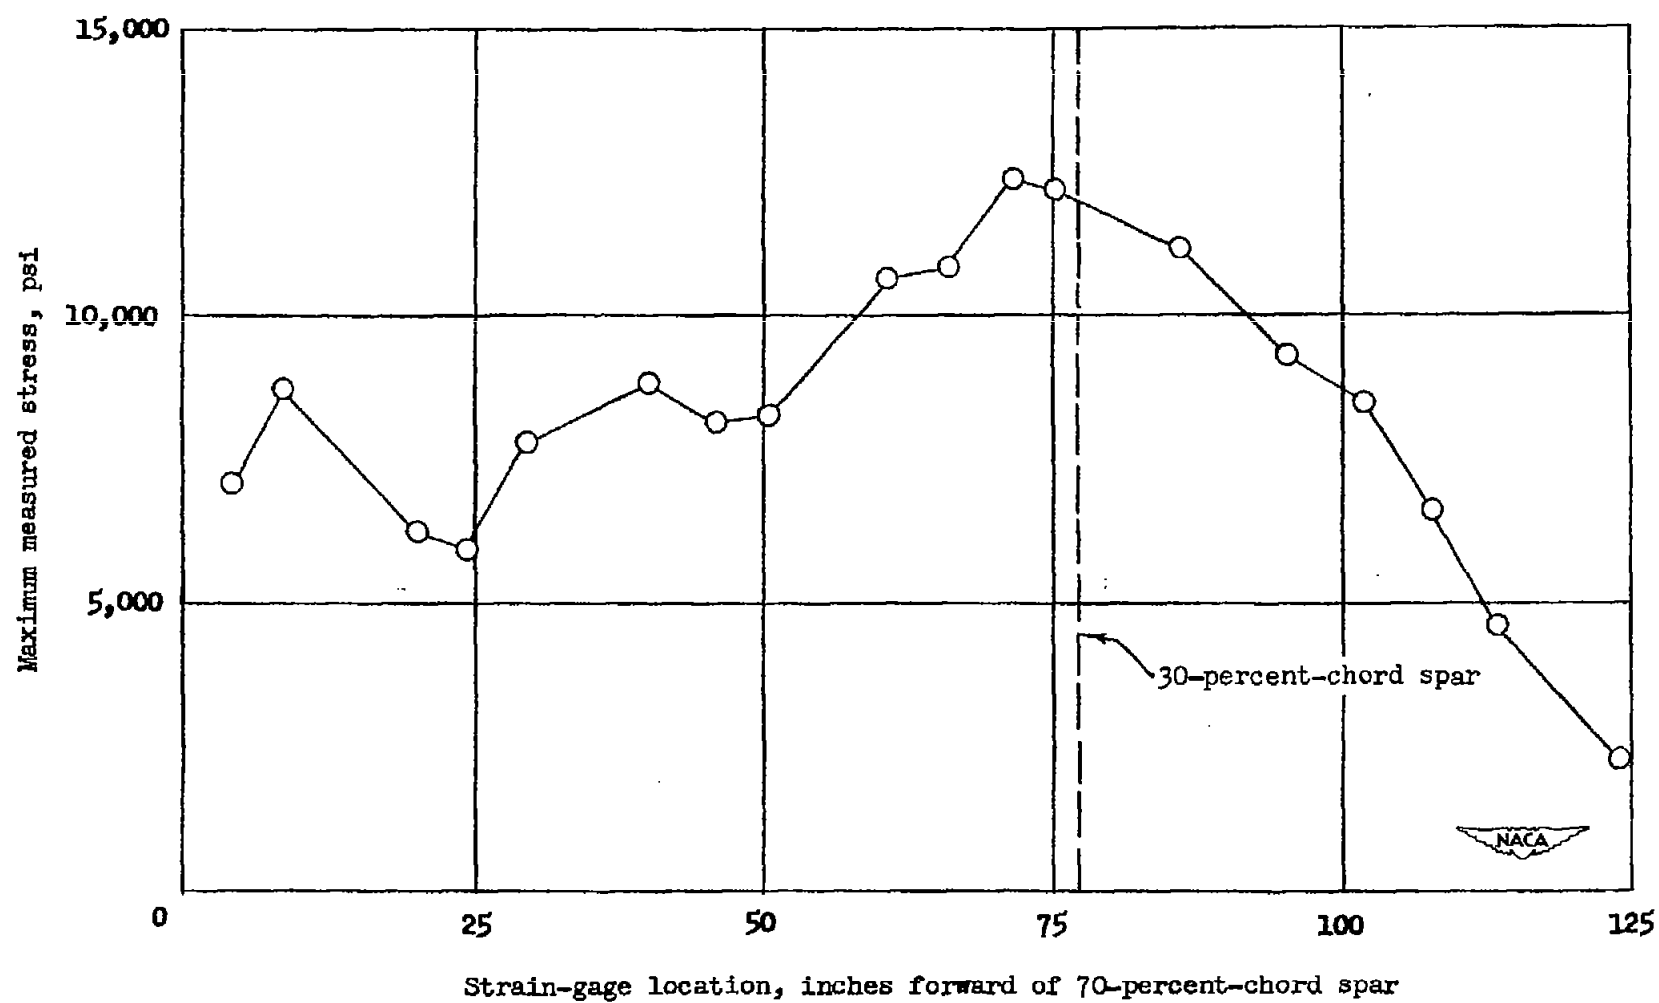
Figure 8.- Chordwise distribution of 1.625g measured stress at station 214.

The failures of type I, which occurred at the corners of inspection cutouts, all originated on the outer panels in the vicinity of span station 214. The chordwise distribution of stress through this section, as measured with strain gages, is shown in figure 8. Failure 3, which is a typical example of this type of failure, is shown in figure 9(a) a short time after starting and again in figure 9(b) after it had progressed to a length of about 17 inches. In figure 9(c) the same crack is shown after causing failure of the spar at the 30-percent-chord position. Another failure of this type is shown in figure 10. The crack originated at the cutout nearest the rear spar at span station 214 and was repeated more often than any other failure of this type. It appeared on all three left wings and on the third right wing. In no case, however, did this crack result in final failure of the wing. The failures originating in this identical location were failures 5, 17, and 33 on the left wing and 26 on the right wing. Failures occurring at the same locations on the left and right wings will be considered as identical for purposes of further discussion.

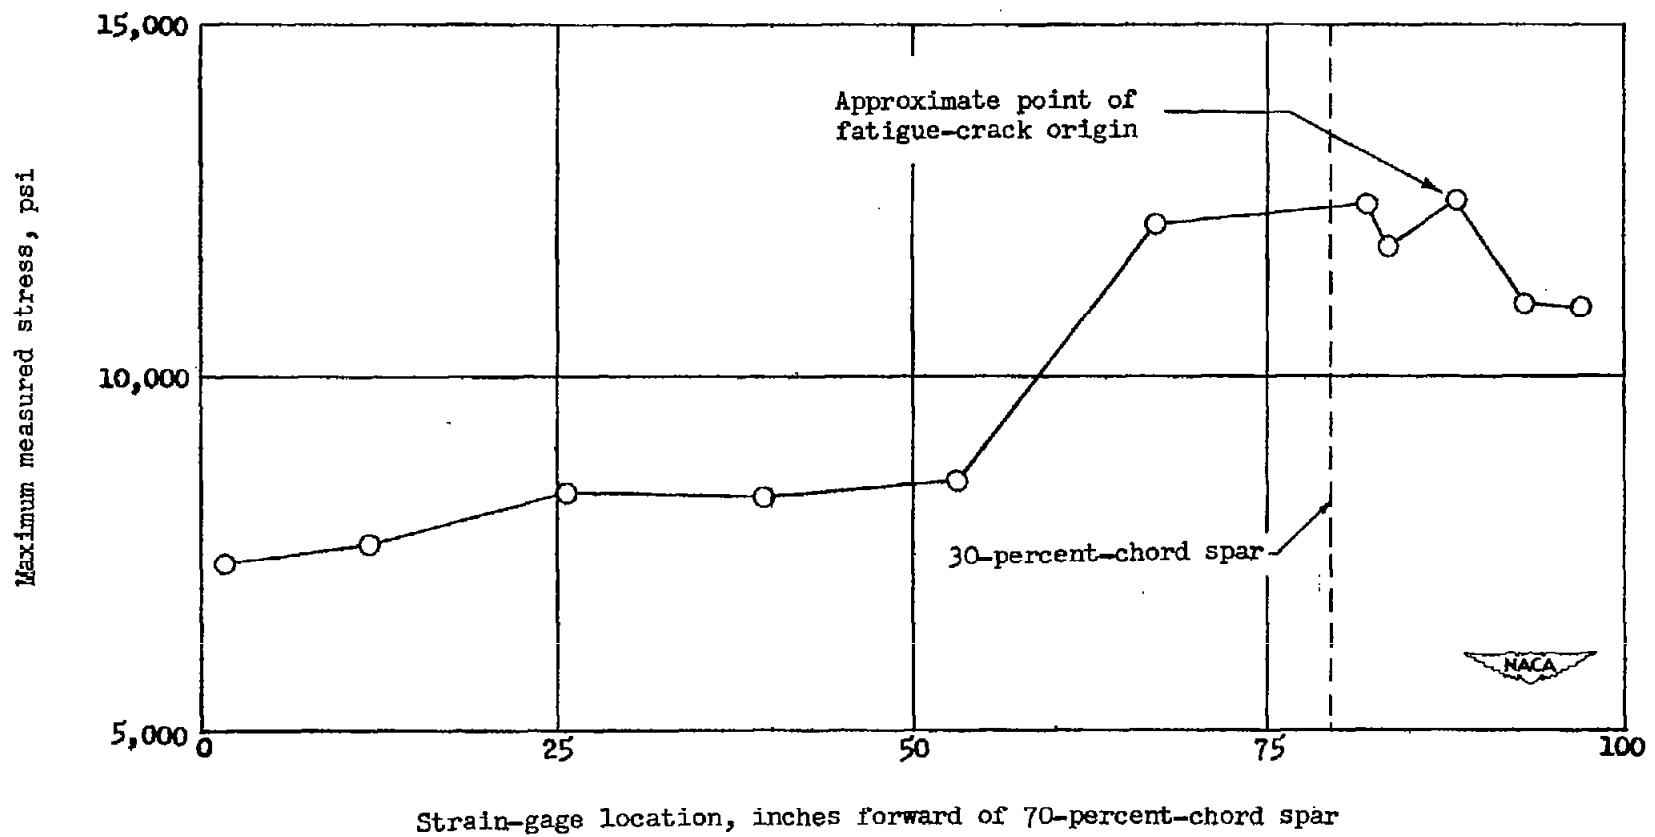
Figure 13.- Chordwise distribution of 1.625g measured stress at station 32.

The second type of failure occurred in a riveted tension joint 32 inches from the aircraft center line. The joint extended chordwise at this wing station from the front spar to the rear spar. Failures of this type appeared on the left and right wing of the first three wing center sections in the same chordwise location and are listed as failures 1, 2, 11, 14, 22, and 23. The details of this joint and the manner of failure are shown in figure 12. The measured chordwise stress distribution through this section is shown in figure 13, from which it may be seen that the highest stress occurs at the point where all the failures originated.

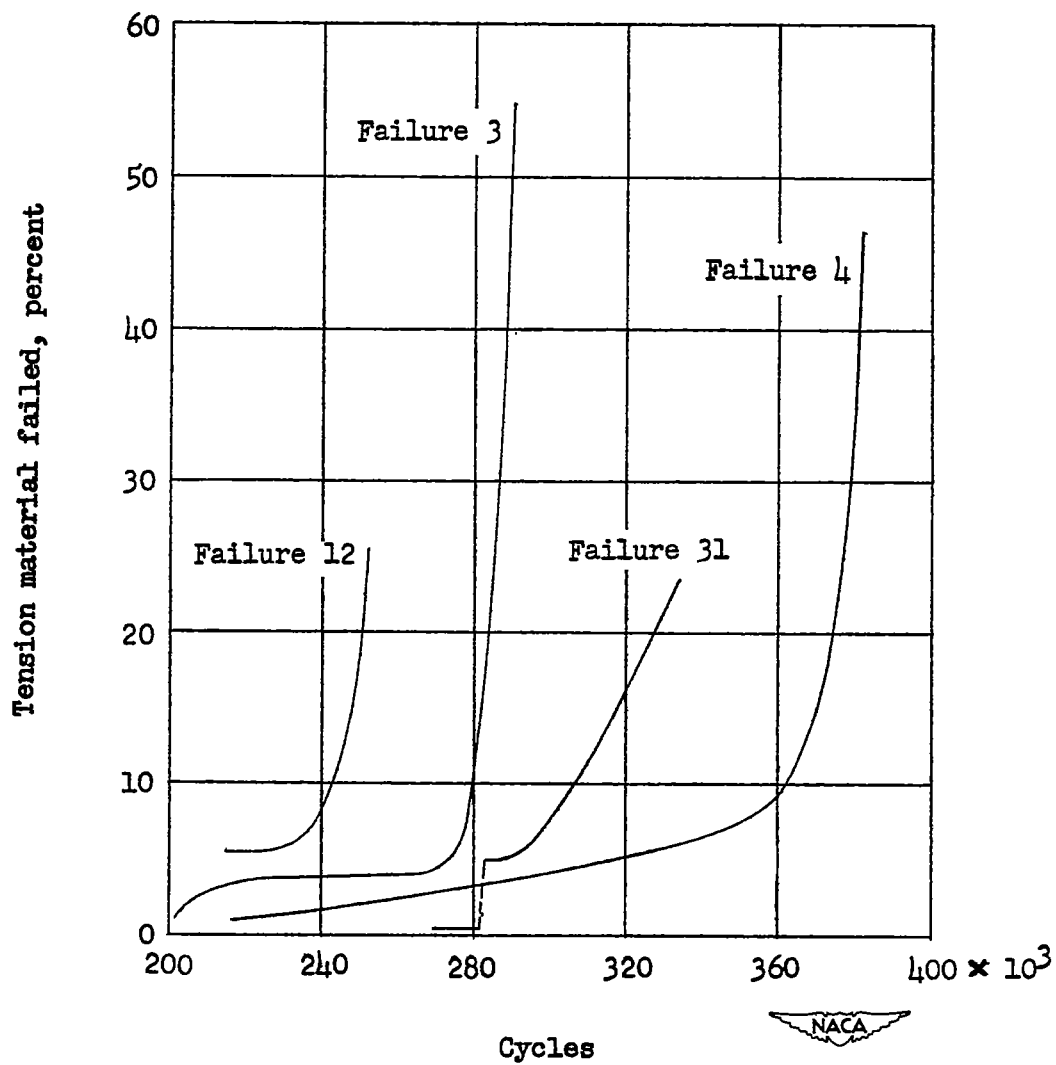
Figure 18.- Crack growth of several fatigue failures.

Several of the fatigue cracks in the wing outer panels were allowed to grow until a considerable amount of the tension surface had failed. The rate at which the cracks grew is shown in figure 18, in which the percent of cross-sectional material failed in the tension surface at the wing station where the failure occurred is plotted as a function of the number of cycles of load applied. The crack-growth curves of figure 18 indicate that the propagation of the cracks was relatively slow until about 5 to 9 percent of the tension material had failed. At this point the slopes of the curves abruptly become very steep and thereby indicate a rapid propagation of the crack thereafter. The abrupt discontinuity in

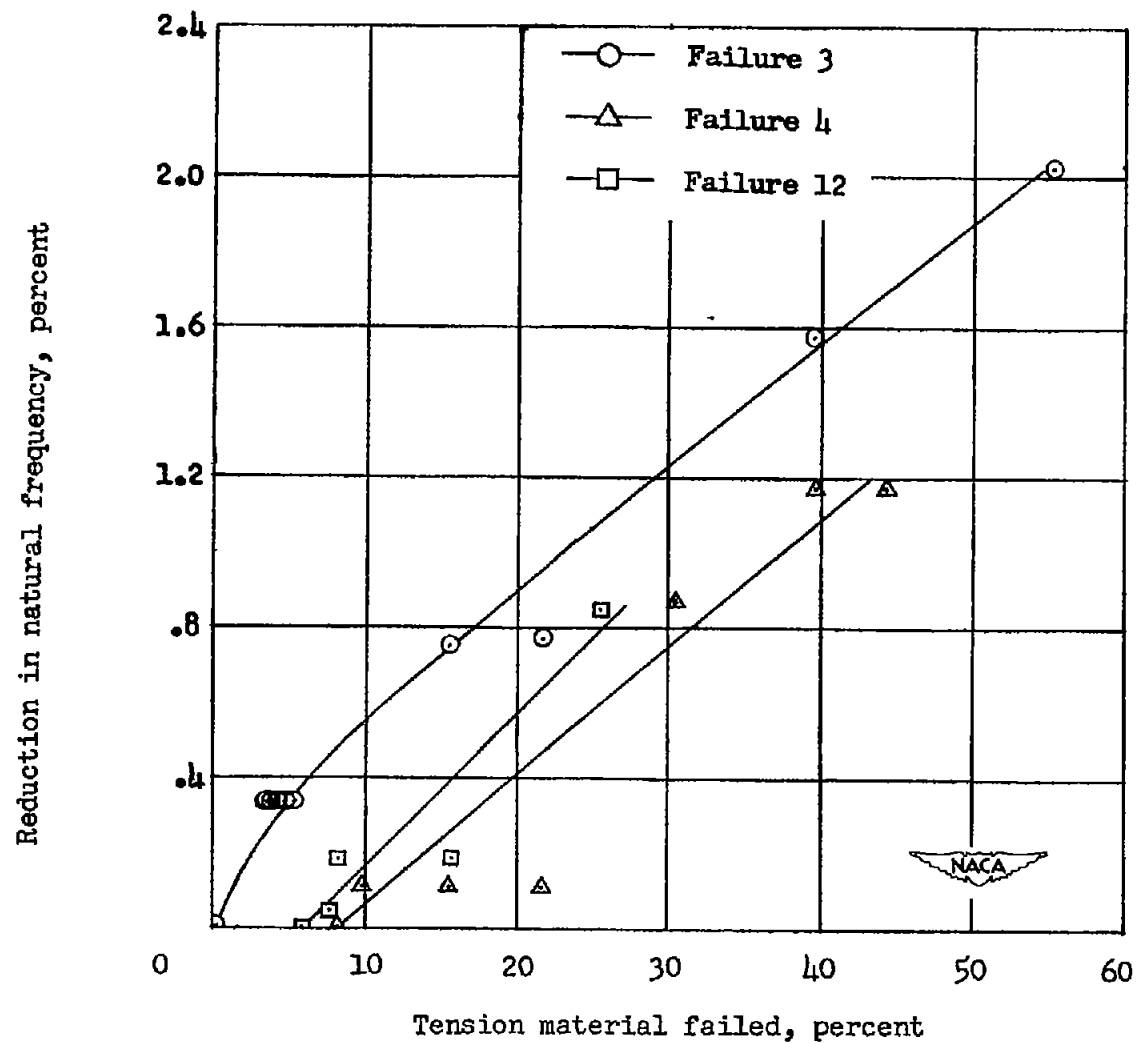
Figure 19.- Variation of natural frequency of test specimen with loss of tension material.

The tests indicated that the natural frequency of the test wings was not affected by fatigue damage until after a fatigue failure had originated. Even then, the change in natural frequency was very small and amounted to only about 2.0 percent with as much as 55 percent of the tension material failed in fatigue. In figure 19 the indicated change in natural frequency is plotted as a function of percent of tension material failed for several of the failures.
